## Water Management Details

### Housewraps/Flashings/Windows

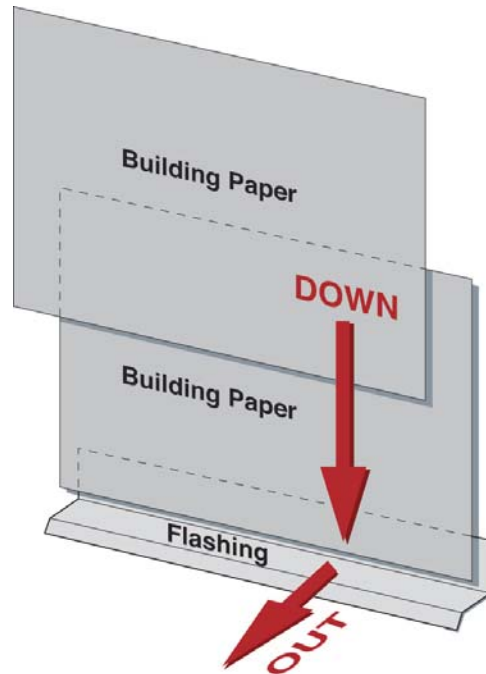
**Figure 1: Shingle lap of drainage plane materials**

An integral part of many water management systems is the use of building paper or housewraps as the drainage plane in the wall system. The basic concepts with these products are that they should always be installed in a shingle lap fashion and have enough space to drain moisture down and out to the exterior. With house wraps, the joints are often also taped to provide increased protection from water entry and to increase the air tightness of the assembly. With no other factors to consider, following these basic ideas should result in long-term performance of the material. While the concept is simple, certain construction methods and details have interfered with the performance of the house wraps and building papers.

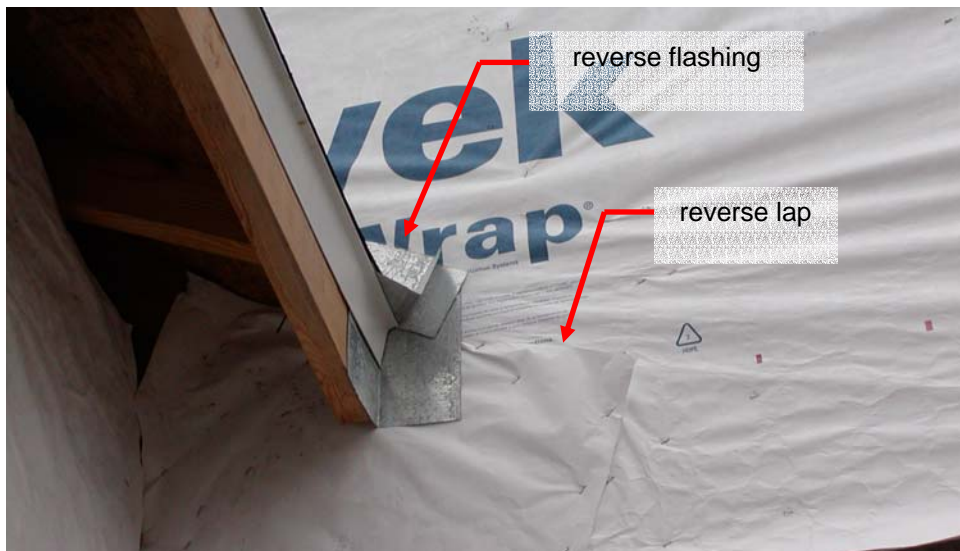
**Figure 2: Improper installation of drainage plane materials**

Maintaining the shingle lap of the building paper or housewrap is generally pretty easy for the field of the wall. Problems usually appear at areas where there is a change in construction, specifically at window intersections and at roof wall connections. These are also often areas of higher liquid water concentration which further exacerbate the problem.

This occurs due to improper sequencing of the construction, or though the difficulty in installing the products at areas of more complicated geometry. Often at these locations the shingle installation ideal is exchanged for coverage (As long as we get the housewrap everywhere it should be fine, right? Wrong.). When roof overhangs, or other kick outs in construction occur, the installation of the house wrap must be considered carefully to ensure that a reverse flashing is not created. While taping the joints of housewraps can reduce the risk of water entry, it is no substitute for proper shingle lapping of the product.

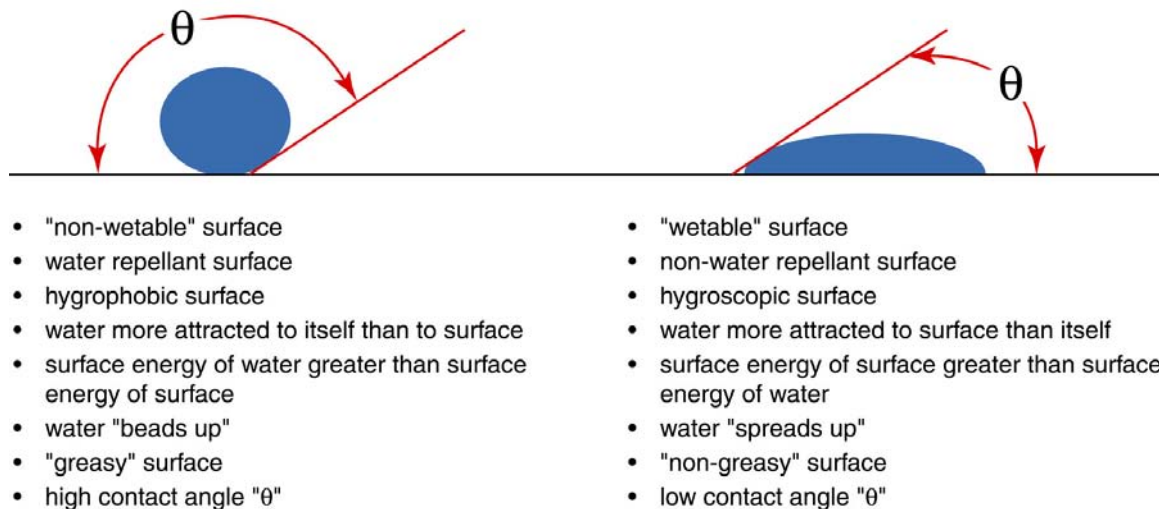
**Figure 3: Hydrophobic and hydroscopic properties**

Similarly to masonry veneers, some sidings installed directly against building paper or housewrap will also hold water up against them. The problem can be even worse with housewraps and wood claddings such as cedar or redwood, due to some water-soluble extractives in wood being a type of surfactant that can contaminate the surface of the housewrap. As the surfactants migrate into the house wrap, the house wrap loses its hydrophobic properties and begins to absorb moisture. This loss of water repellency of the house wrap constitutes a fundamental failure in its role as a drainage plane.

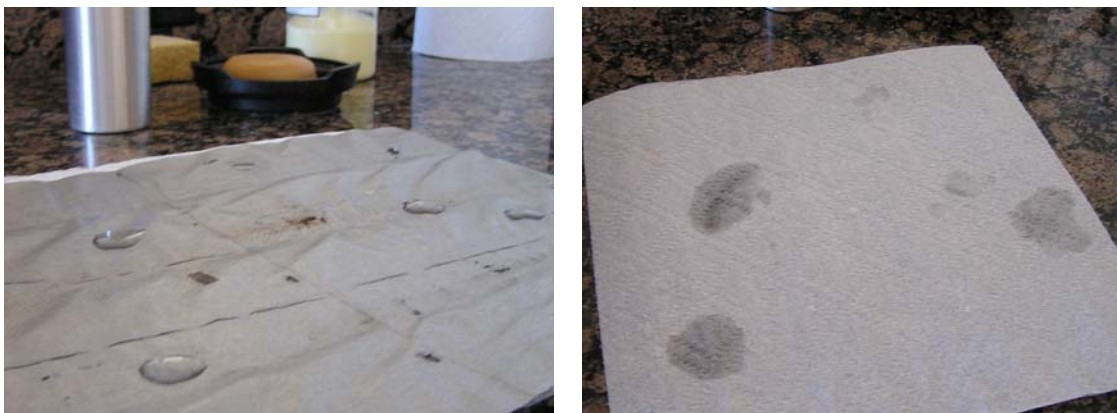
**Figure 4: Failed water drop test of a housewrap**

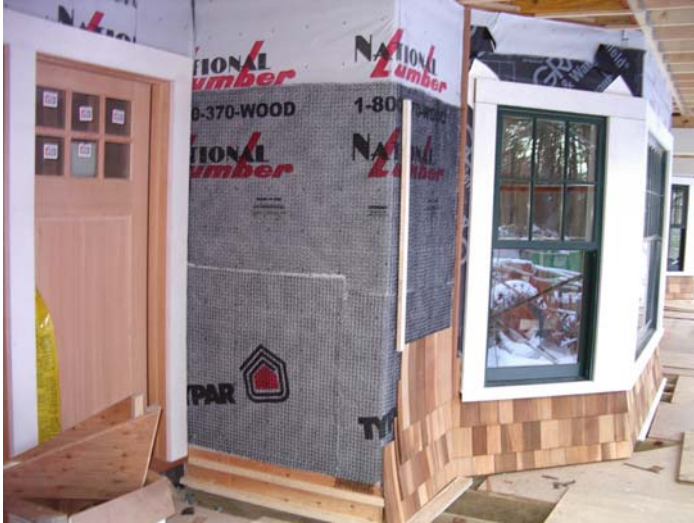
**Figure 5: Drainage matt installed behind wood shingles**

For all sidings (except vinyl) it is recommended that they be installed over some form of drainage matt or furring strips in order deal with the problems of water retention and potential surfactant contamination. This spaces the siding off of the housewrap to prevent surfactant contamination, increases drainage, and often increases drying by ventilation as well. Furring strips are a more traditional method of moving the siding off of the back up wall construction, however from past experience both methods have been very successful at managing the moisture problems with board sidings and house wraps.

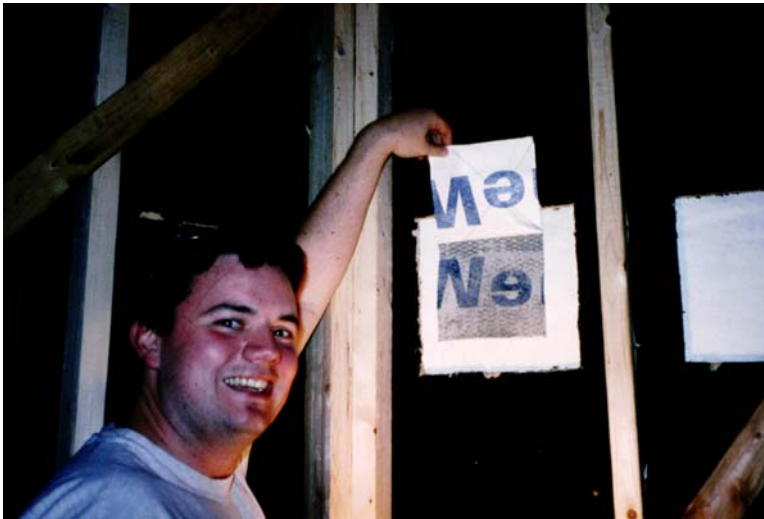
**Figure 6: Stucco renderings bonded to house wrap**

In the case of stucco, thin brick, and cultured stone claddings, renderings tend to bond to all plastic housewraps and some building papers. This reduces or eliminates the ability of the assembly to drain.

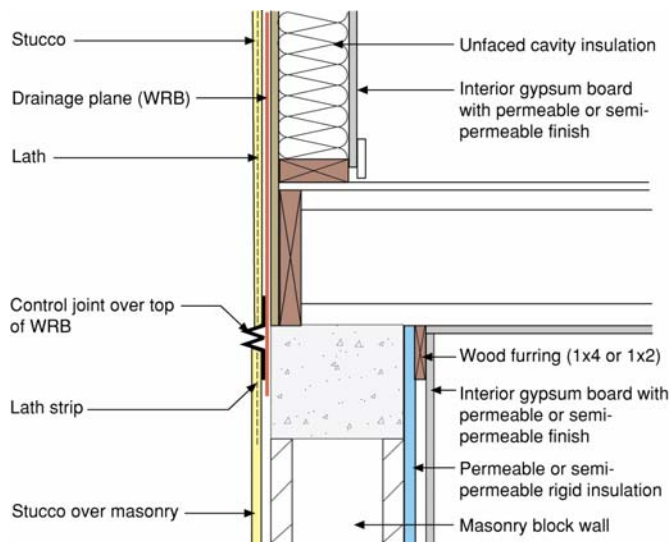
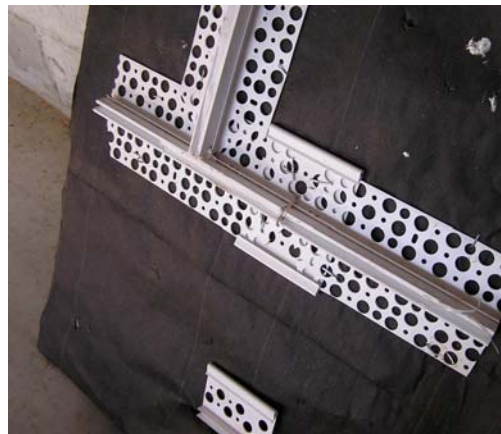
**Figure 7: Control joint over top of building paper (not recommended)**

Other drainage plane concerns with stucco can be created when there is a change in the back up wall construction. In Florida it is common for the main floor of the house construction to be concrete block while the top floor is wood frame. Stucco is commonly installed directly onto the concrete block with no building paper installed behind the stucco. This barrier cladding approach can be used successfully due to the capacity of concrete block to absorb water and dry out under more favorable conditions. The problem occurs at the transition between the drained and barrier cladding approach. Standard stucco installation practices have created a reverse flashing at this location. The stucco control joint is traditionally installed over top of the building paper. This directs the water towards the interior at the top of the masonry block.

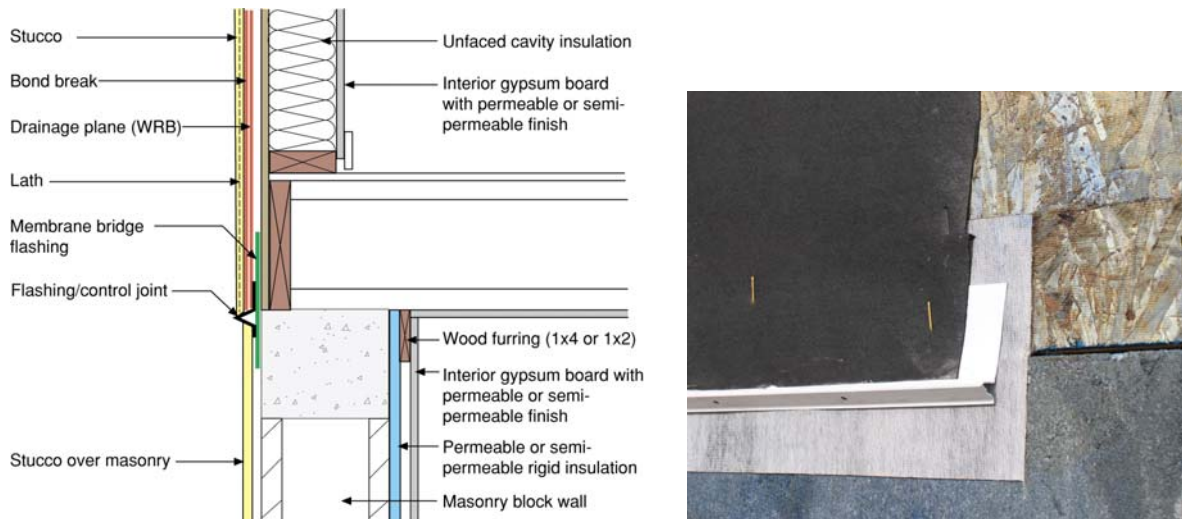
**Figure 8: Weep screed used as a control joint with building paper shingle lapped over top of the flange**

This problem can be corrected by using a weep screed for the control joint and ensuring that the building paper drainage plane is installed in a shingle lap fashion over the screed. In addition, the transition joint should also be protected by a strip of waterproof self adhered membrane. The membrane flashing will prevent moisture that builds up at the base of the stucco just above the screed from being driven to interior at this location.

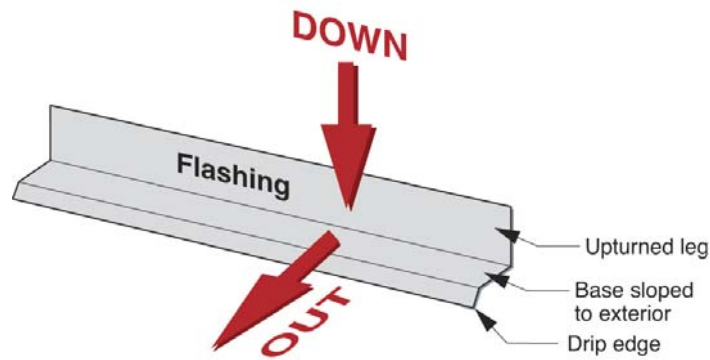
**Figure 9: Basic flashing principles**

Flashings should all be sloped in the direction of drainage. This may seem like a simple enough concept to incorporate into the design, however, surprisingly the most fundamental failure mechanism for a flashing installation is through installing the flashing with a reverse slope. With reversed sloped flashings water is held by the flashing and drains to the side and off the ends of the flashing back into the assembly. This can also hold water up against claddings and other materials, potentially reducing the service life of the products. All flashings should be installed with a positive slope to drain to the exterior.

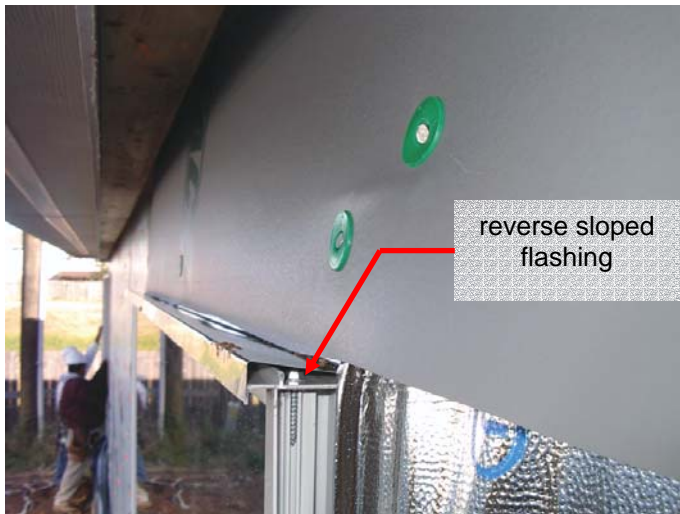
**Figure 10: Reverse sloped flashing**

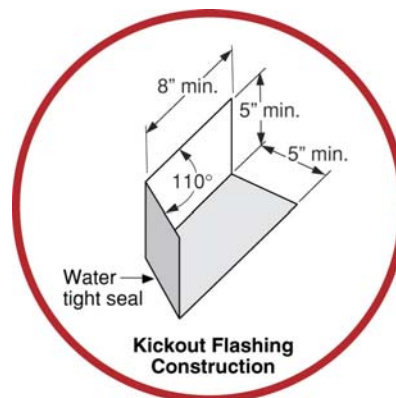
**Figure 11: Kick out flashing conceptual design**

Kick out flashings are used at the bottom edge of a roof to wall intersection, where the roof ends and the wall continues on. They are used to direct the water out from below the cladding at the step flashing plane and away from the wall. This prevents water from draining off the roof and into the wall system below. It also helps aesthetically, as it prevents unsightly stains on the wall cladding from roof drainage.

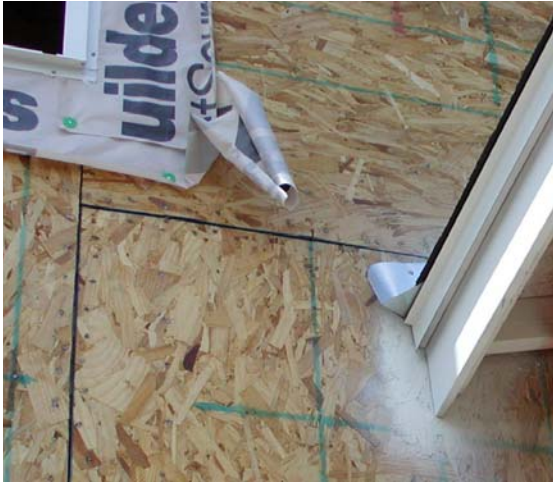
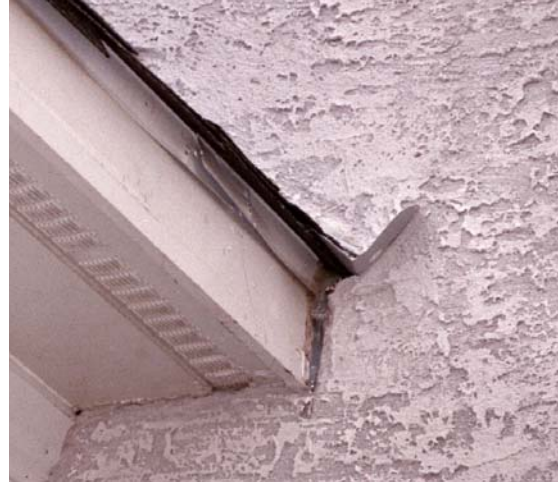
**Figure 12: Kick out flashing installations**

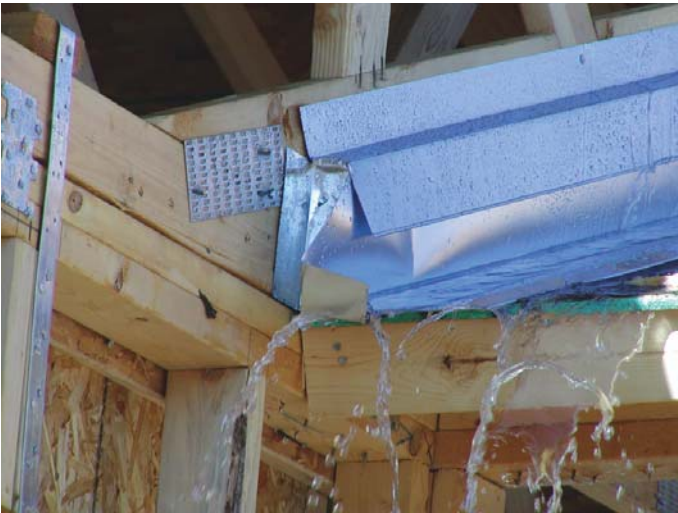
**Figure 13: Poorly folded kick out flashing**

In order for the kick out flashing to be effective, the bottom seam must be properly sealed or folded to ensure that water does not leak through the joint. Improperly folded or sealed kick out flashings will cause a high water concentration to be poured behind the cladding.

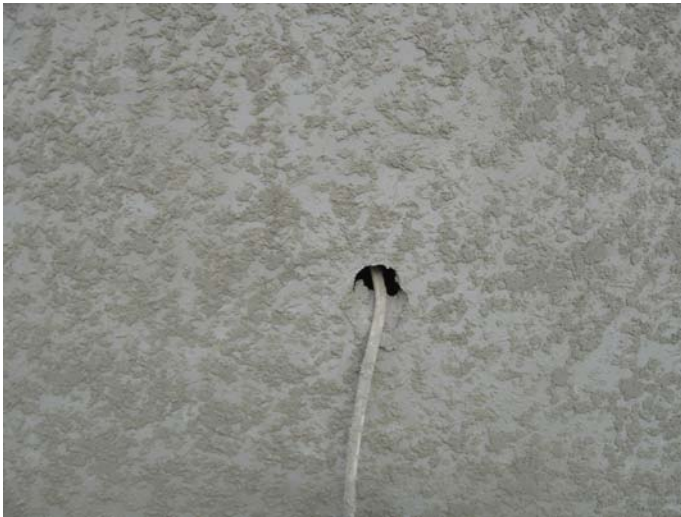
**Figure 14: Electrical utility installed after water management system**

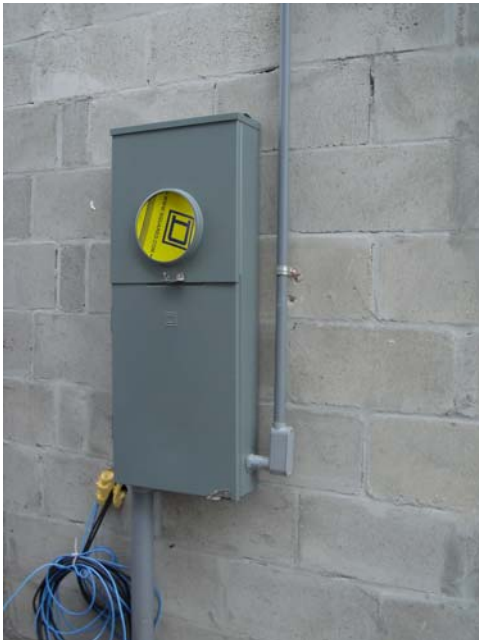
**Figure 15: Panel installed before installation of the drainage plane**

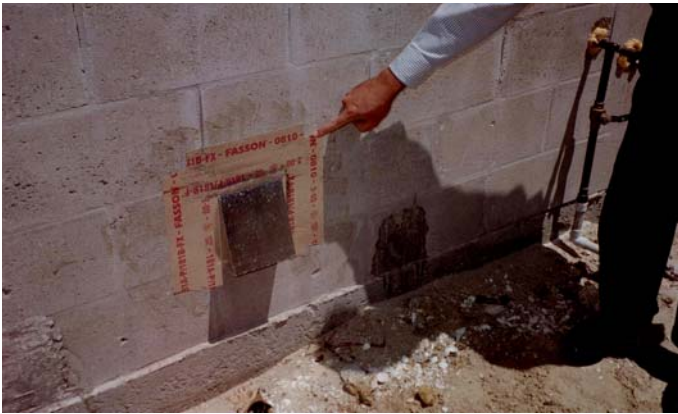
**Figure 16: Membrane flashed exhaust vent**

Mechanical penetrations, including exterior lighting, electrical boxes, dryer vents, gas utility penetrations etc. need to be properly flashed and integrated into the design of the water management system. This can often be achieved through the use of self adhered membrane flashings. Some products are also available that provide flanges that can be sealed and shingled lapped into the drainage plane permitting these penetrations to be more easily incorporated into the water management system.

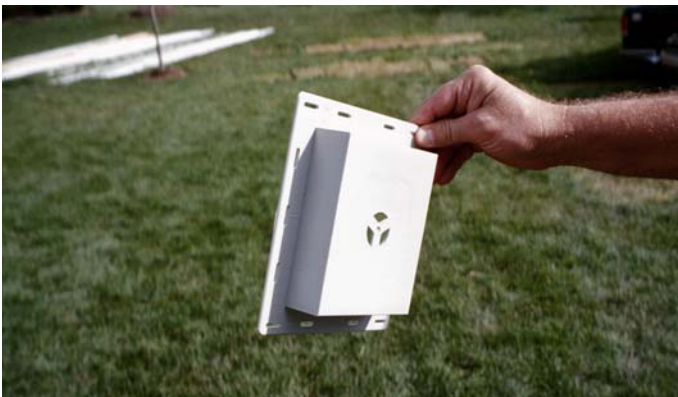
**Figure 17: Flanged electrical box**

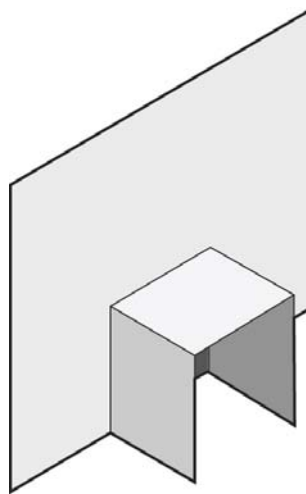
**Figure 18: Saddle flashing conceptual design**

Saddle flashings are used in locations where building elements penetrate through the cladding and are attached to the back up wall construction. This occurs at such places as balcony railings, porch framing attachments, retaining walls, and some mechanical penetrations.

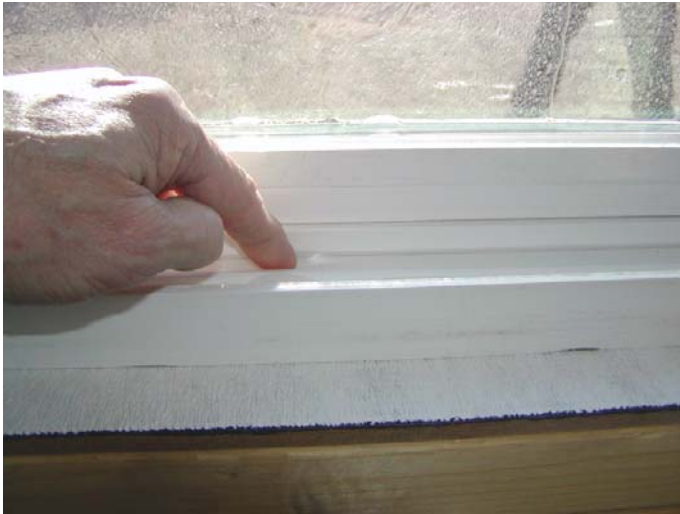
**Figure 19: Water intrusion through the window frame**

Leaks from windows have existed as long as windows have existed. Water not only leaked through the windows themselves, but also around the windows at the interface between the rough opening and the window frame. In many older solid masonry buildings this was not a problem due to the capacity of the construction to absorb moisture and dry out under more favorable conditions. As the construction industry changed, materials and assemblies began to be used that had less of a capacity to manage moisture. The absorption capacity and the drying potential of assemblies were significantly reduced. This led to serious building enclosure failures related to window leakage.

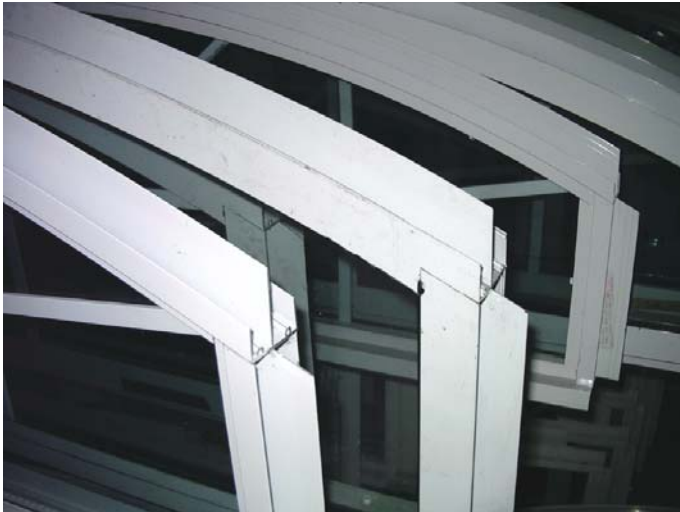
**Figure 20: Discontinuity of the nailing flange at the corners**

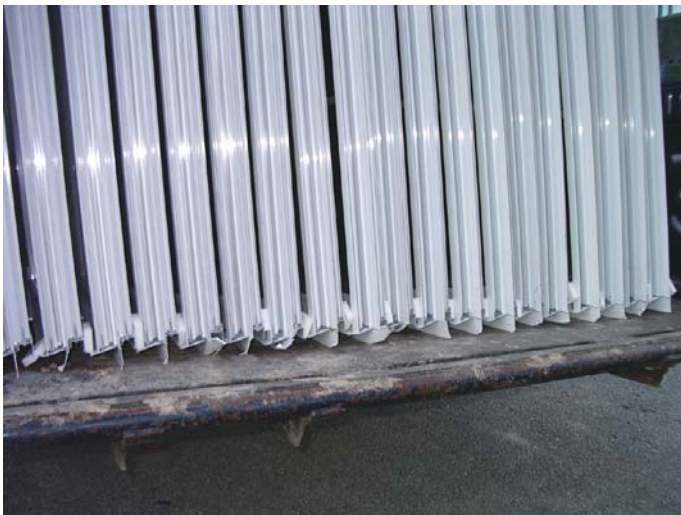
**Figure 21: Bent and damaged nailing flanges being delivered to site**

The nailing flange is usually a thin PVC or metal fin that is part of the frame extrusion and generally not very strong. These flanges can be damaged, bent or broken during the delivery or installation of the window system into the wall assembly, or may not be continuous around the window depending on the assembly at the corner joints of the frame. Damaged and broken nailing fins can lead to fundamental failures in the integrity of the drainage plane of the wall assembly as membrane tapes and building papers/housewraps no longer have adequate area of material to adhere to or cover over the flange.

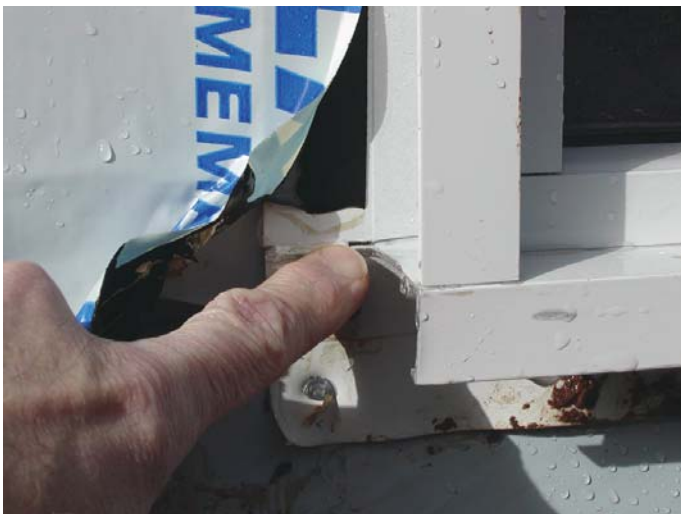
**Figure 22: Cracked nailing flange at corner connection**

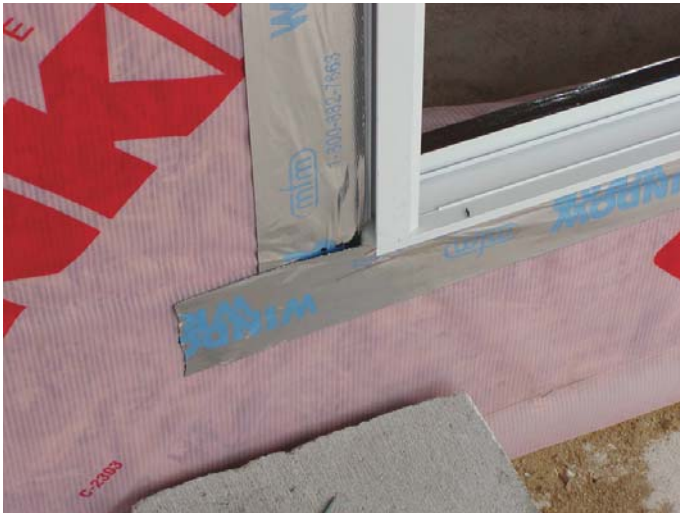
**Figure 23: Reverse lap of self adhered membrane at window sill in a barrier installation**

As long as the nailing flange is continuous and undamaged it can be effectively integrated into the moisture management of the wall assembly. Self adhered membranes are often used to integrate the nailing flange into the drainage plane of the water management system of the wall assembly. Self adhered membranes used to seal to the nailing flange must be installed, as with other water management concepts, in a shingle lap fashion to prevent reverse laps that can create paths for water intrusion. While this concept is generally understood, repetitive installations and requirements to complete the installations in a timely manner, has led to poor installations and problems with installation.

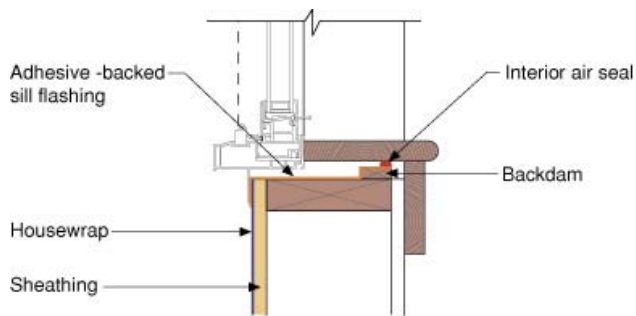
**Figure 24: Sill and backdam options**

A strip of wood nailed at the back of the rough opening sill forms a dam to prevent water from draining into the interior

Ideally, the pan flashing would be sloped to the exterior. This can be achieved through the use of a section of board siding laid flat under the pan flashing. In cases where positive slope to drain is not practical, then a back dam should be installed to prevent water from draining back to the interior.

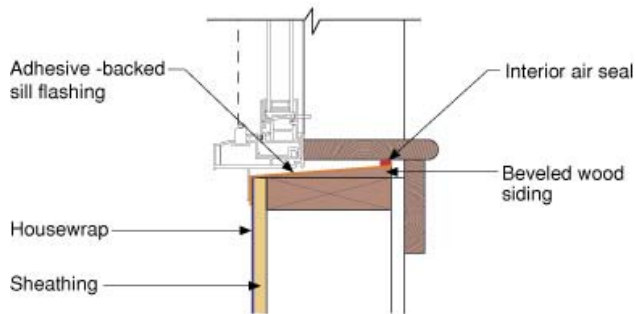
A piece of wood bevel siding nailed over the sill to create positive drainage toward the exterior is even better.

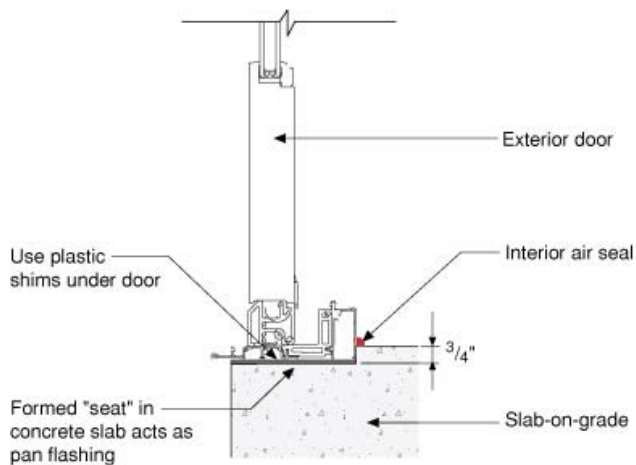
Forming a depression in a cast-in-place floor slab creates a built-in drainage pan for mulled entry doors and sliders, which are prone to leakage at joints.

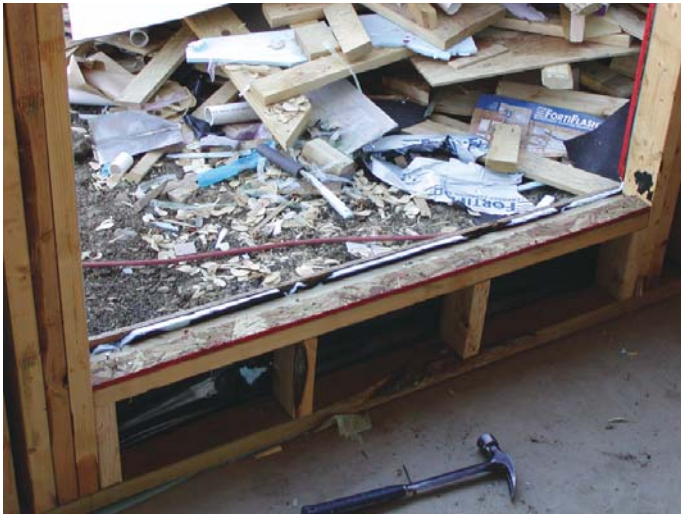
**Figure 25: Drainage blocked due to exterior sheathing above the sill framing**

The condition of the rough opening can affect the performance of the drainage of the pan flashing. The exterior sheathing must not extend higher than the sill framing. In this situation, even with a perfectly installed pan flashing, the drainage of the system will be compromised.

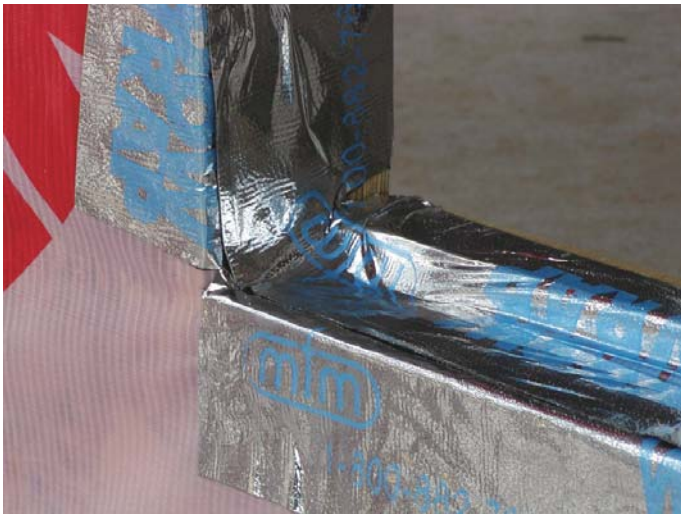
**Figure 26: Tenting of the membrane pan flashing in the corner**

Tenting of the membranes occurs when the membrane pieces are not seated properly into the corners of the sill rough opening. The result is a curved fillet, placing the flashing in tension with a void beneath. Because of this tearing of the membrane can occur during the installation of the pan flashing, or the sharp corners of the window frame can cut or damage the reinforcing of the membrane leading to failures in the integrity of the pan flashing.

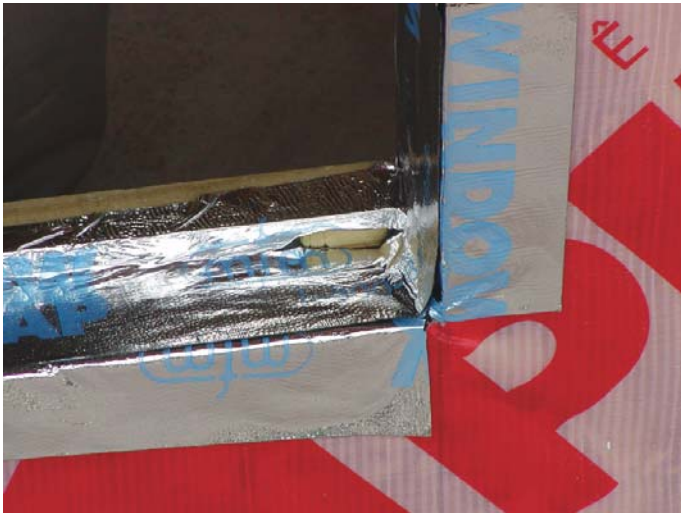
**Figure 27: Torn membrane pan flashing**

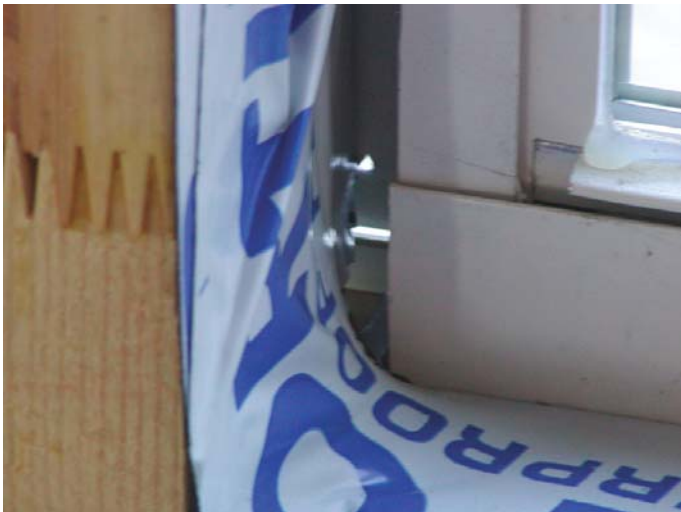
**Figure 28: Window corner cutting into improperly seated pan flashing**

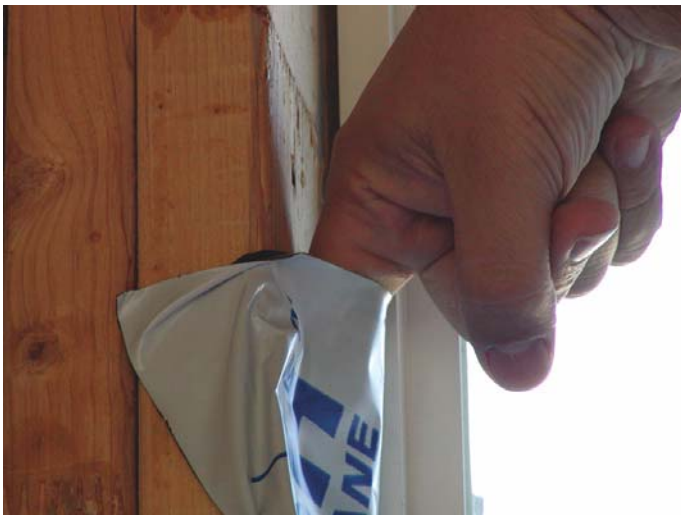
**Figure 29: "Fishmouthing" of the membrane**

Rushed installations also lead to problems with poor membrane installations and “fishmouths”. “Fishmouths” act as a funnel to direct water into the construction.

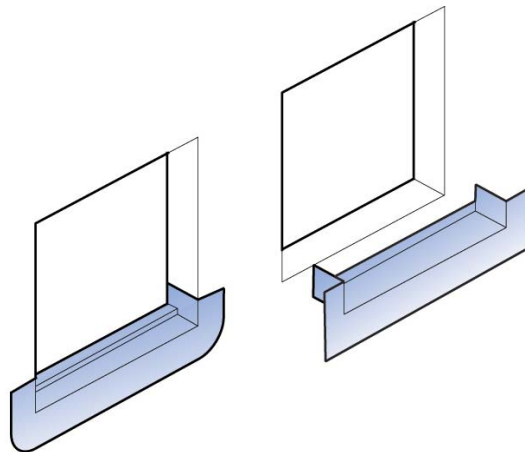
**Figure 30: Moldable membrane and preformed plastic pan flashings**

As a means to correct some of these concerns, other products available on the market such as moldable membrane flashings and preformed plastics can be used for the installation of the pan flashing. Moldable membrane flashings allow for a single piece of membrane to be installed at the corner of the sill as the membrane can stretch to fan out and curve around corners.

Preformed plastic pan flashings have also been developed to address this problem of time consuming and finicky work of creating pan flashings with membranes. The preformed plastic sections usually have integrated backdams as well. With these products the jambs and sill joint between the two pieces must still be sealed with membrane to prevent water intrusion below the pan flashing.

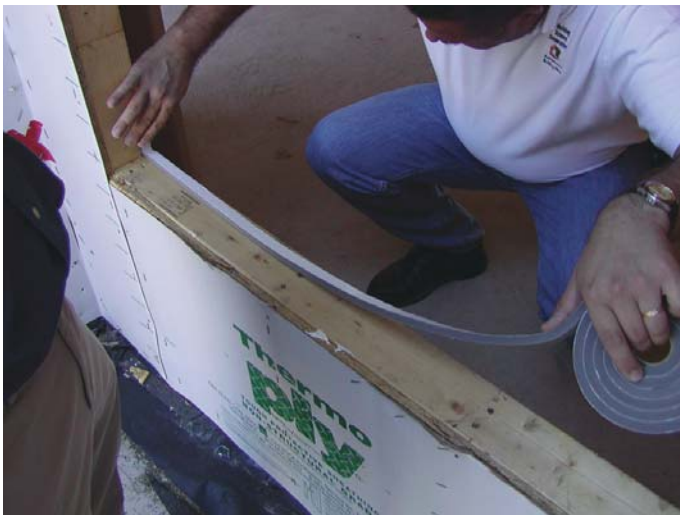
**Figure 31: Weather seal gasket used as a backdam**

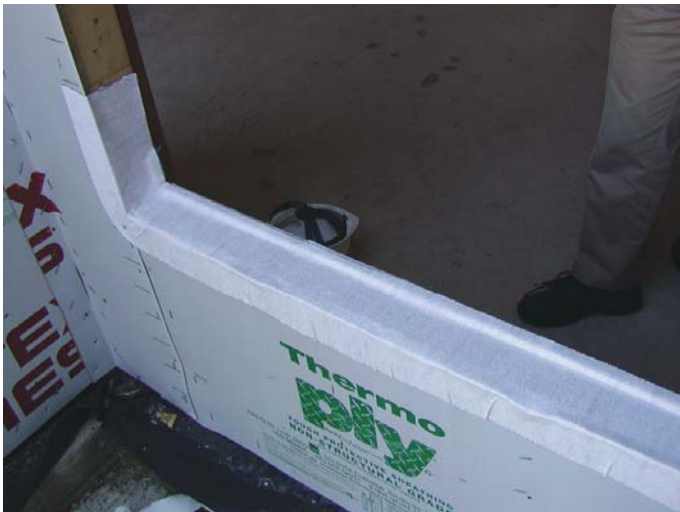
**Figure 32: Single piece moldable membrane pan flashing with backdam**

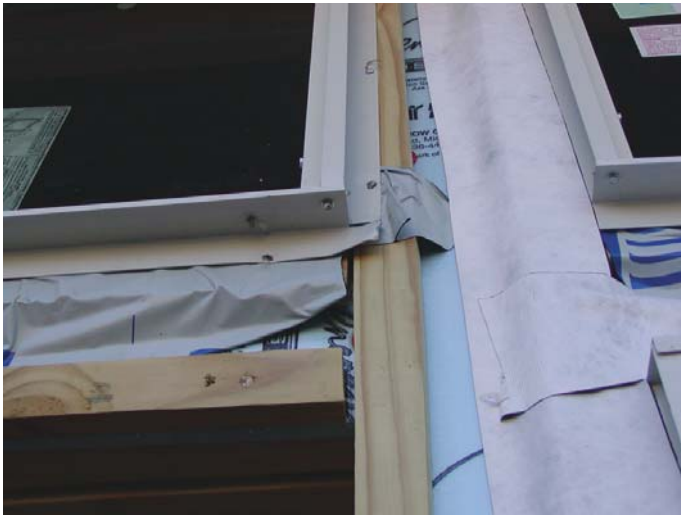
**Figure 33: Window furred out from the drainage plane (not recommended)**

The furring strips move the window out of the drainage plane of the wall assembly. This adds more three dimensional complexity to the window, flashing, and housewrap installation details. Clearance requirements between adjoining assemblies can also become an issue. Most sheet good products become difficult to install in locations where there are multiple changes in plane in a relatively small location, often leading to poor installations and discontinuities in the drainage plane.
